DE LOREAN MOTOR COMPANY

SERVICE BULLETIN

NUMBER ST-22-10/81

SUBJECT: WIRING HARNESS ROUTING ON RIGHT (REAR) BULKHEAD PANEL

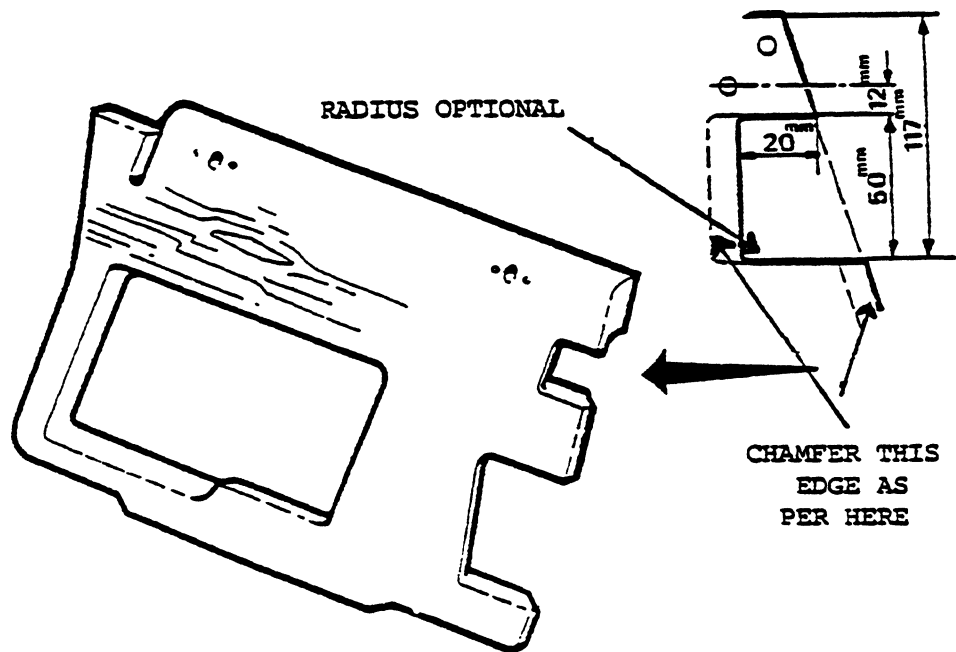
From V.I.N. 2309, a recess has been cut out of the right rear bulkhead panel to accommodate the wiring harness. See the diagram below.

This modification may also be made on earlier vehicles to improve harness routing.
