STS-107  
Launch+4 Day  
Consolidated Film/Video Report  
KSC, JSC, MSFC and Program Integration  
Film/Video Analysis Teams

# Thermal Analysis Assessment of Debris Impacted Lower Surface in STS-107 Mission Locations

# Predicted Impact Area Derived from Film Observations and Trajectory Analysis

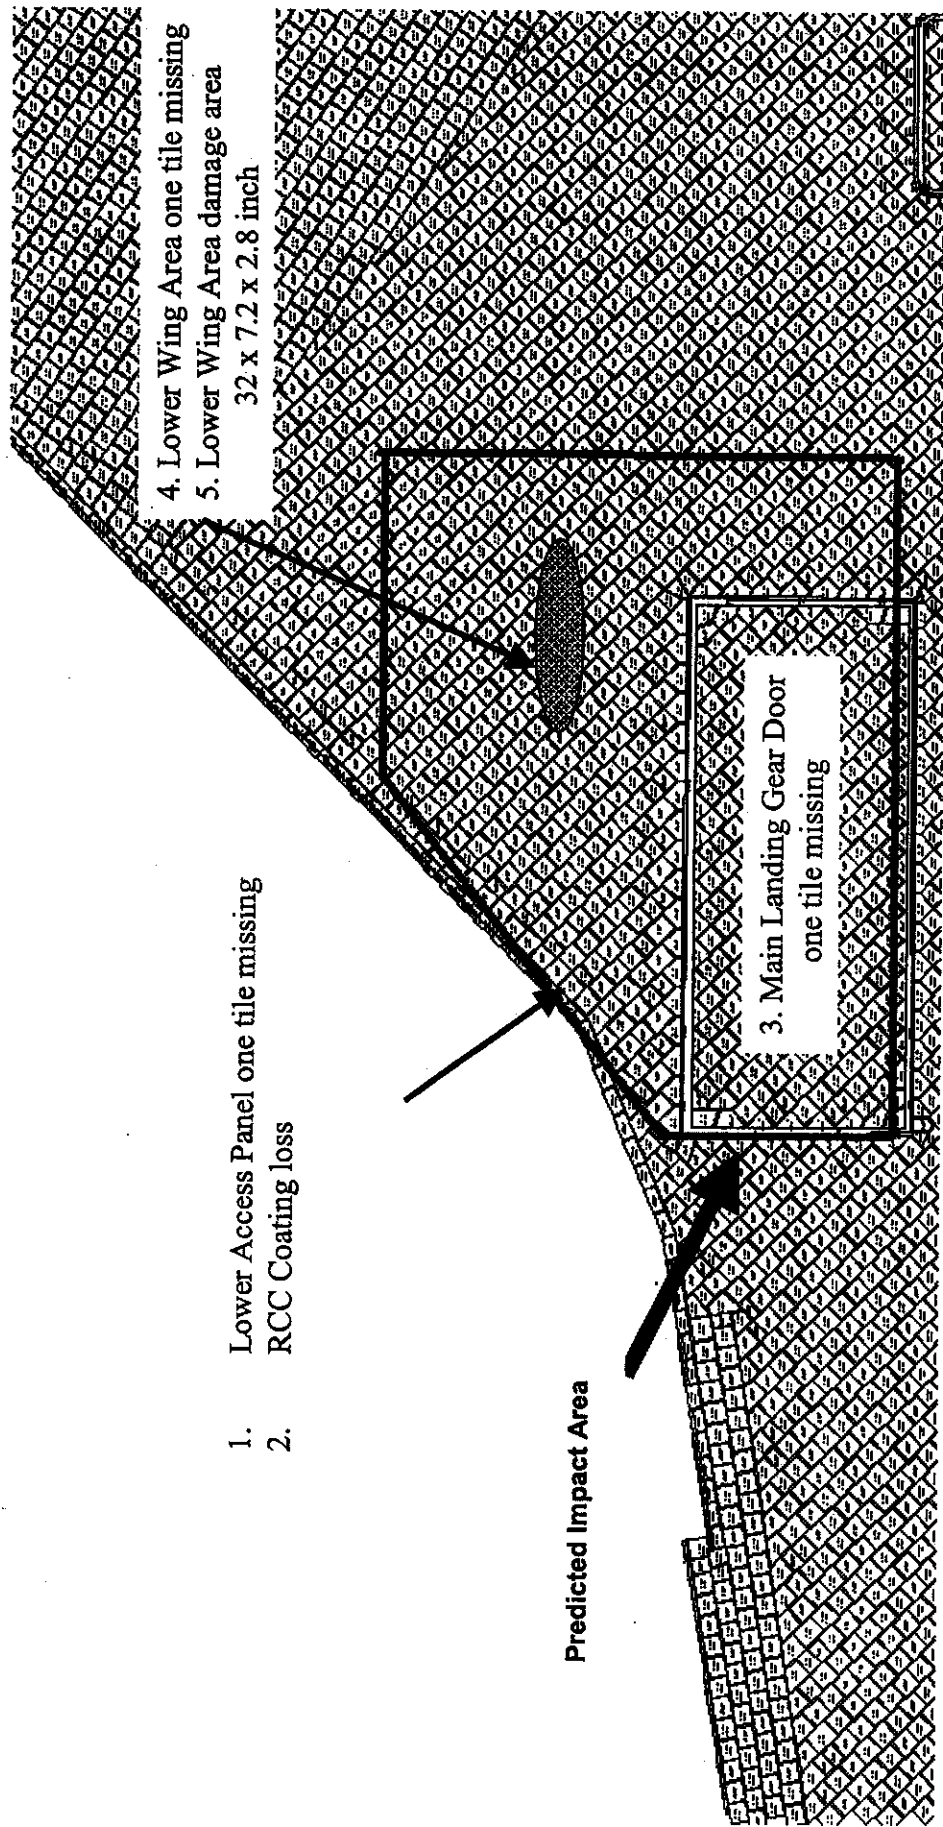
Case	Location	Assumptions	Results
1	Access Panel (one tile missing)	Loss to last layer of TMM Densified layer ~ .2 inches	Temperature of Al Tube Carrier 790 °F No issue
2	RCC Panel 9 Lower Flange OML (Coating Missing)	Coating loss and Carbon substrate exposed	Substrate thickness: 0.193 inches Loss .09 inches No issue
3	Main Landing Gear Door (one tile missing)	Loss to last 2 layers of TMM Densified layer ~ .4 inches	Temperature of Structure 540 °F No issue
4	Lower Wing Area (one tile missing)	Loss to last 2 layers of TMM Densified layer ~ .4 inches	Temperature below 350 °F No issue
5	Lower Wing Area (32 x 7.2 x 2.8 inch) Damage	Loss to last layers of TMM Densified layer ~ .2 inches	
6	Main Landing Gear Door (several tiles Lost)	Loss to last layers of TMM Densified layer ~ .2 inches

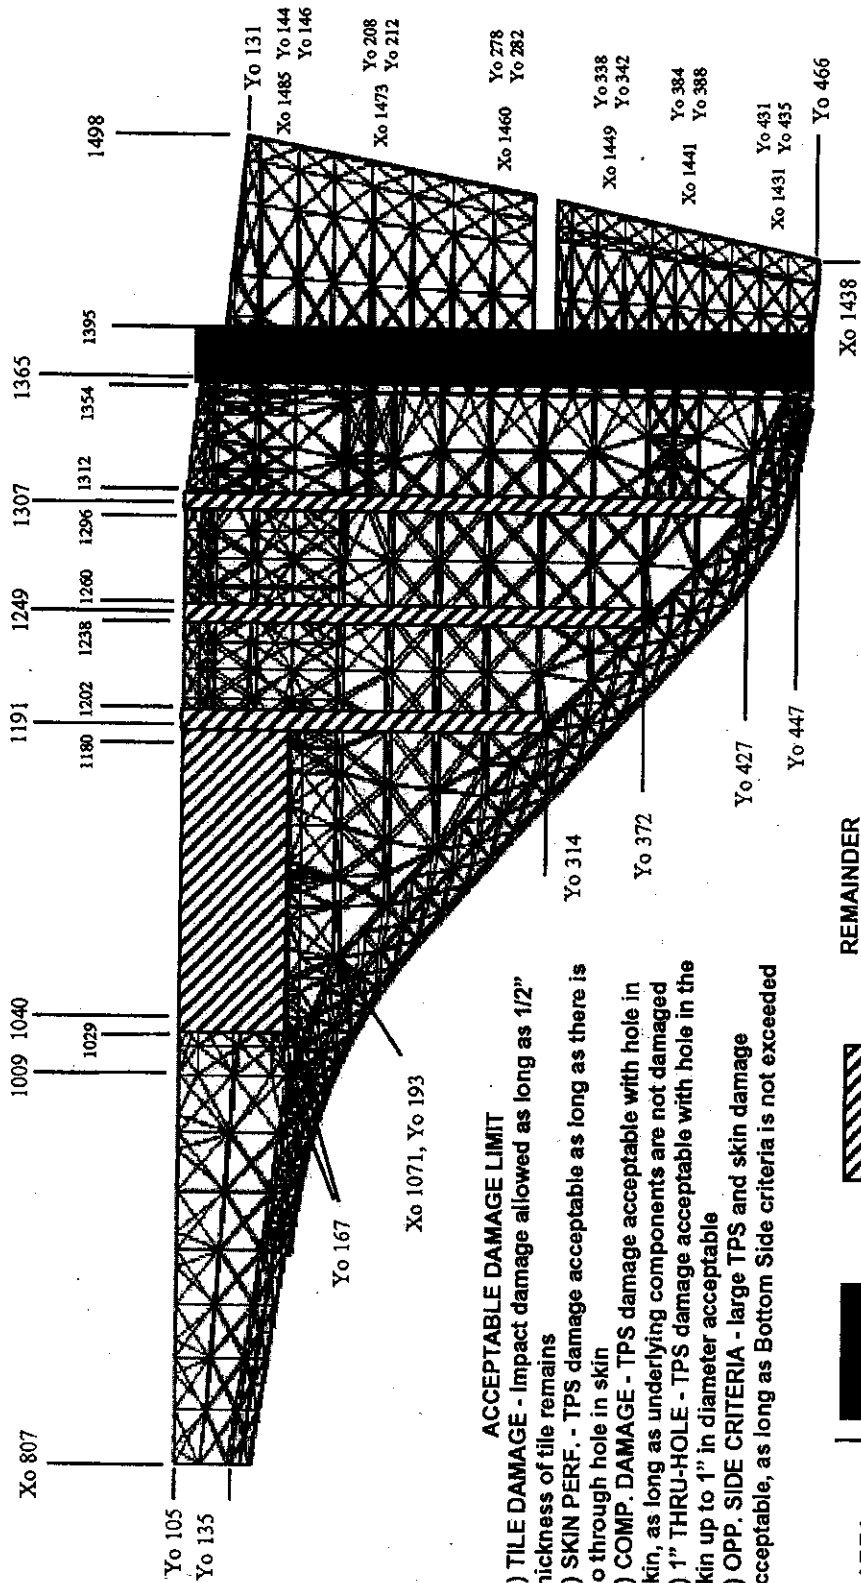
# Wing Lower Surface M/OD Failure Criteria

- 1) **TILE DAMAGE** - Impact damage allowed as long as  $1/2''$  thickness of tile remains
- 2) **SKIN PERF.** - TPS damage acceptable as long as there is no through hole in skin
- 3) **COMP. DAMAGE** - TPS damage acceptable with hole in skin, as long as underlying components are not damaged
- 4) **1" THRU-HOLE** - TPS damage acceptable with hole in the skin up to  $1''$  in diameter acceptable
- 5) **OPP. SIDE CRITERIA** - large TPS and skin damage acceptable, as long as Bottom Side criteria is not exceeded

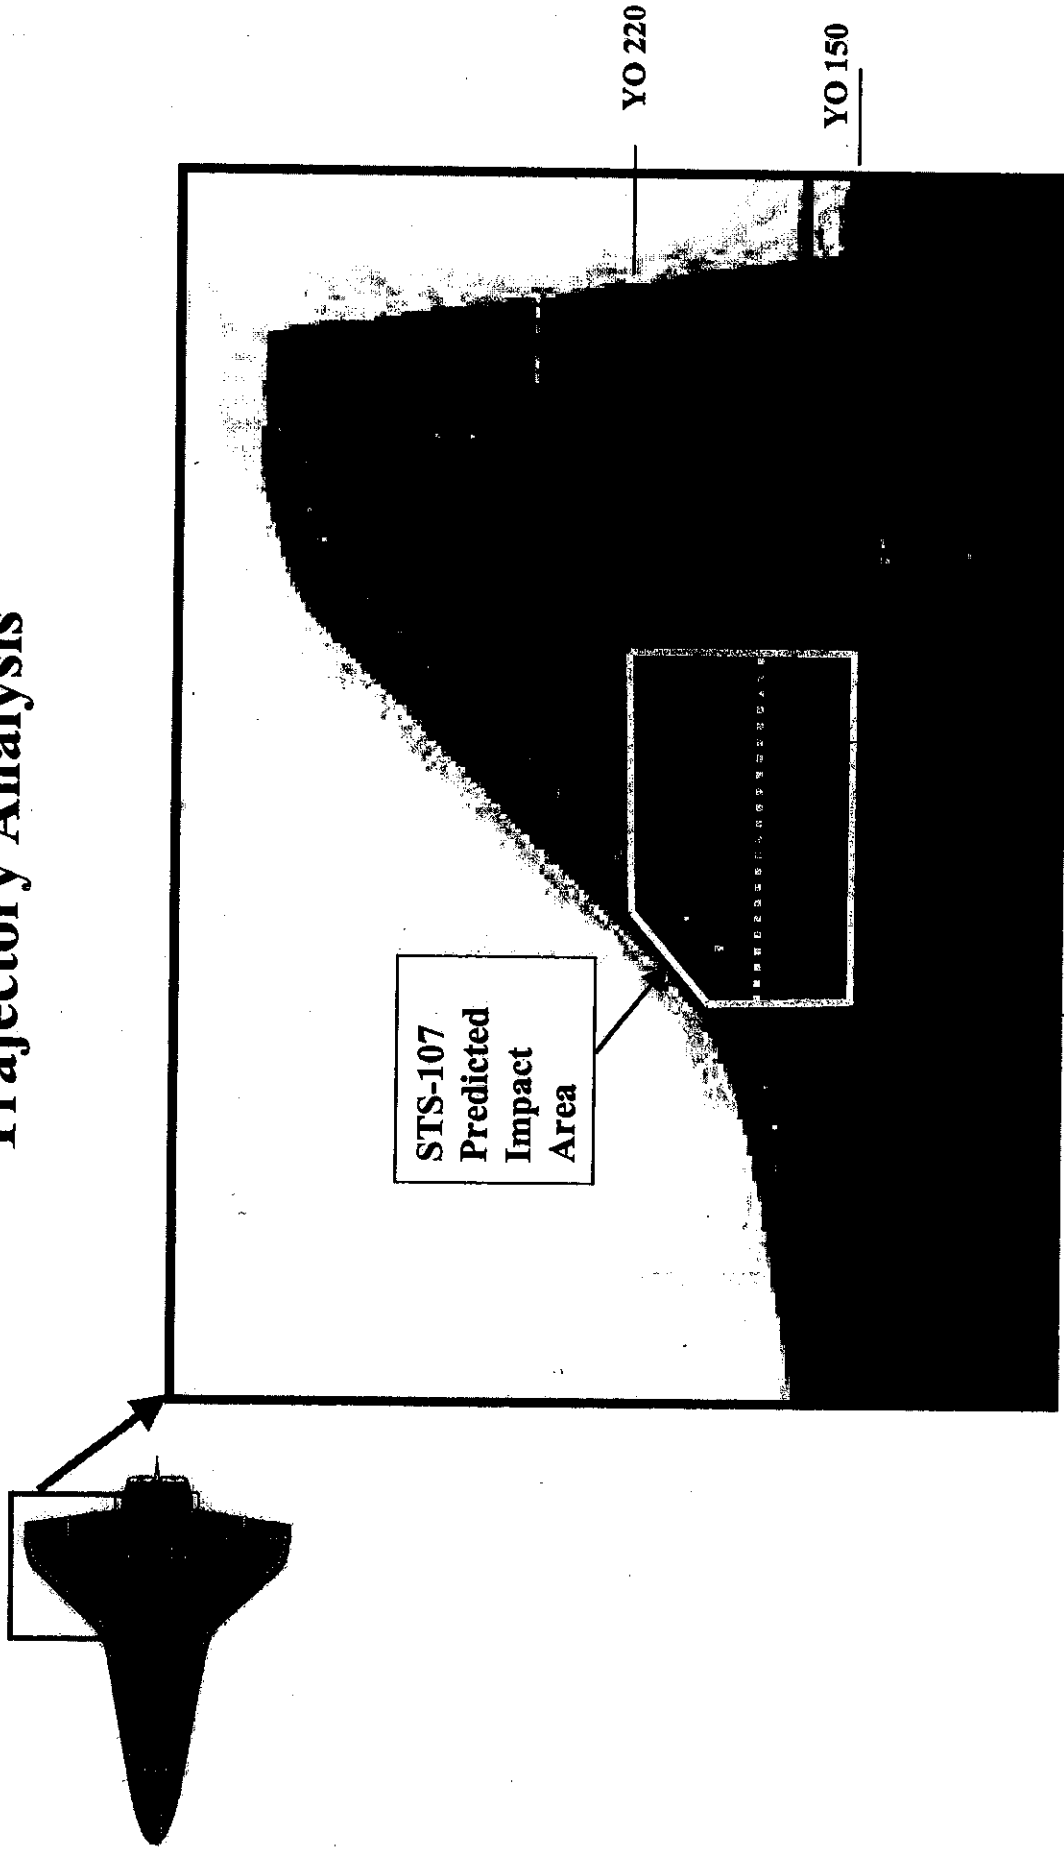
A preliminary assessment of debris impact conditions predicted an impact to the Orbiter lower surface at location Xo1049, Yo185 (results provided on January 17, 2003) Impact velocity was estimated to be approximately 750 ft/sec with an impact angle estimated to be less than 20 degrees.
