STS-107  
Launch+4 Day  
Consolidated Film/Video Report  
KSC, JSC, MSFC and Program Integration  
Film/Video Analysis Teams

# Thermal Analysis Assessment of Debris Impacted Lower Surface in STS-107 Mission Locations

# Predicted Impact Area Derived from Film Observations and Trajectory Analysis

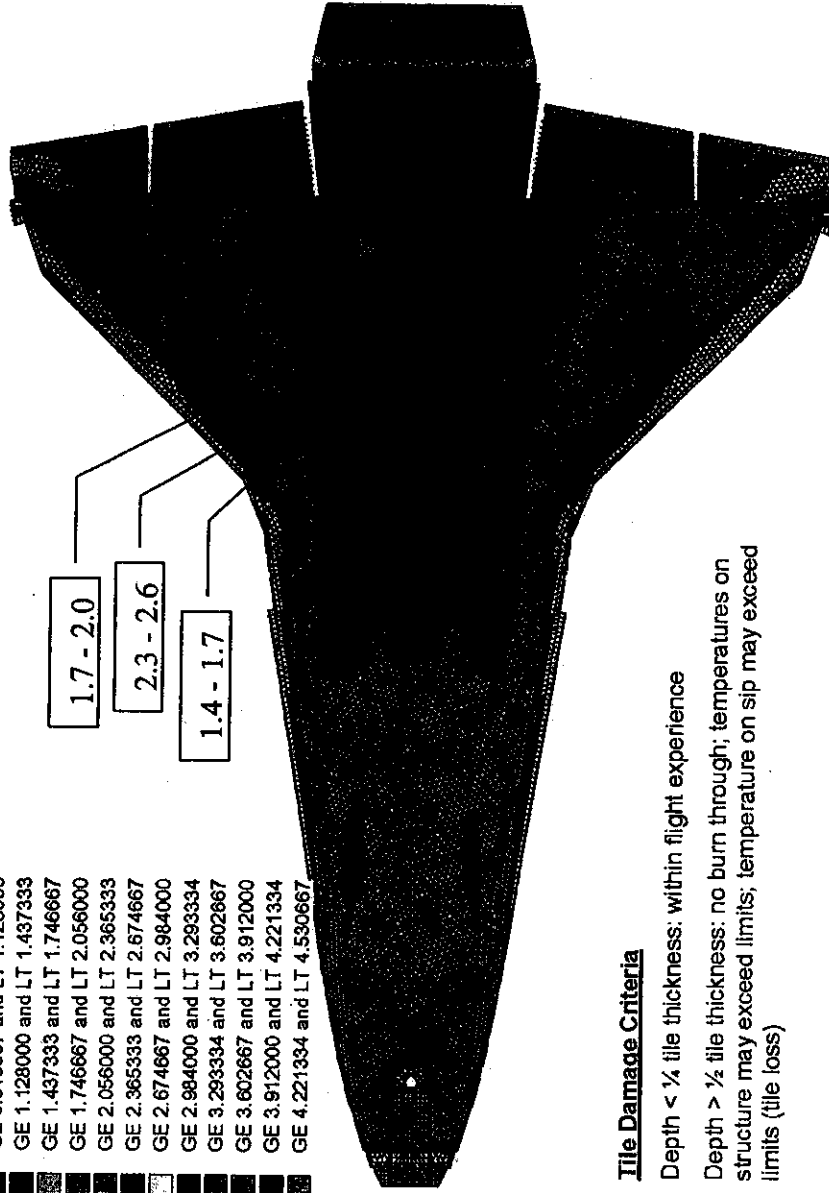
# Tile Thickness

## Tile Damage Criteria

Depth < ¼ tile thickness; within flight experience  
 Depth > ½ tile thickness; no burn through; temperatures on structure may exceed limits; temperature on sip may exceed limits (tile loss)

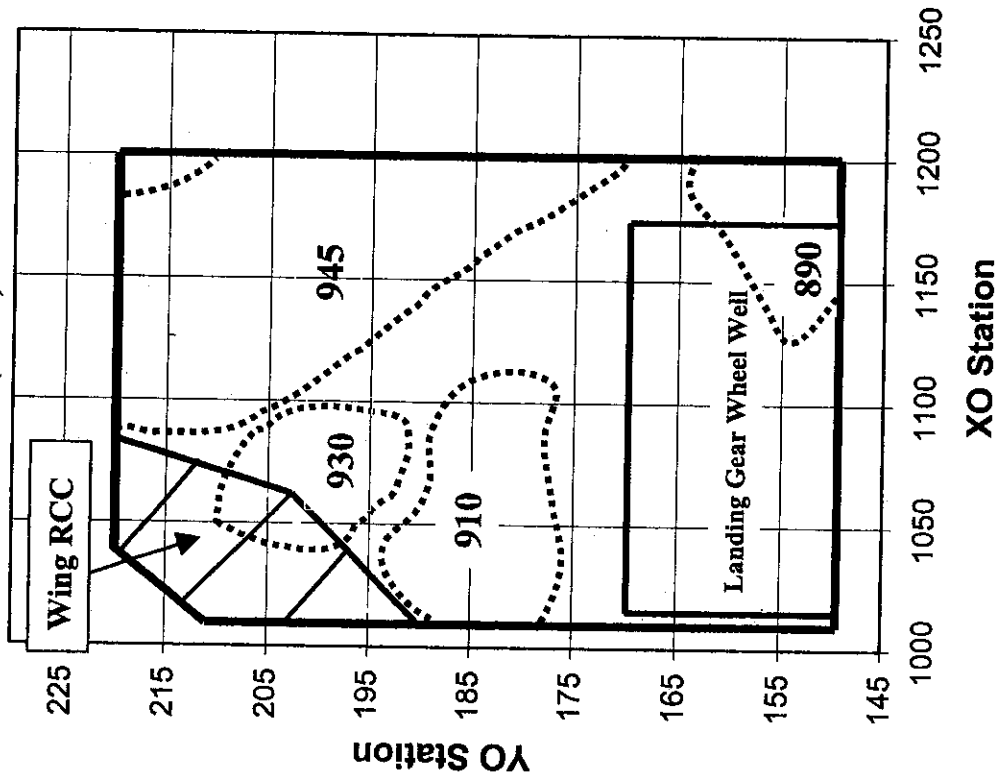
**Impact Velocity**  
(ft/sec.)

# Velocity and Impact Angle Distribution Inside Impact Area (Debris Size = 20" x 10" x 2", Density = 2.4 lb/ft<sup>3</sup>)

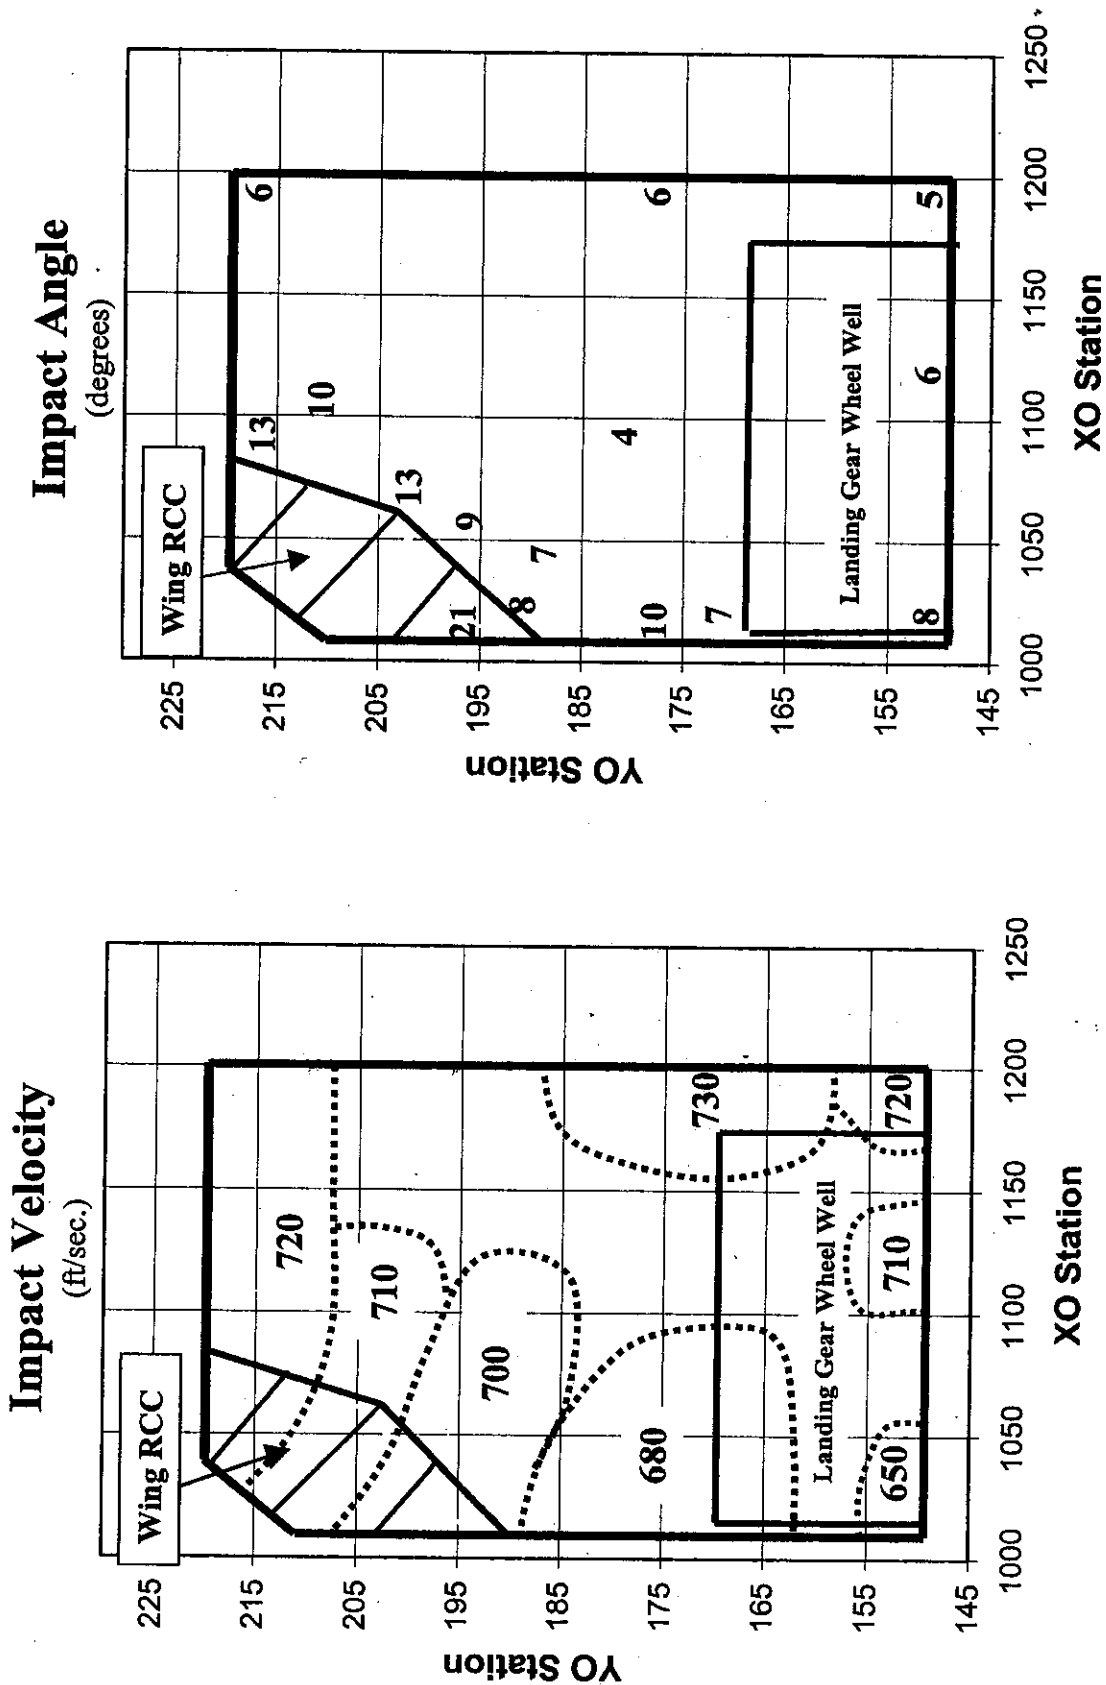
# Velocity and Impact Angle Distribution Inside Impact Area

(Debris Size = 20" x 10" x 6", Density = 2.4 lb/ft<sup>3</sup>)

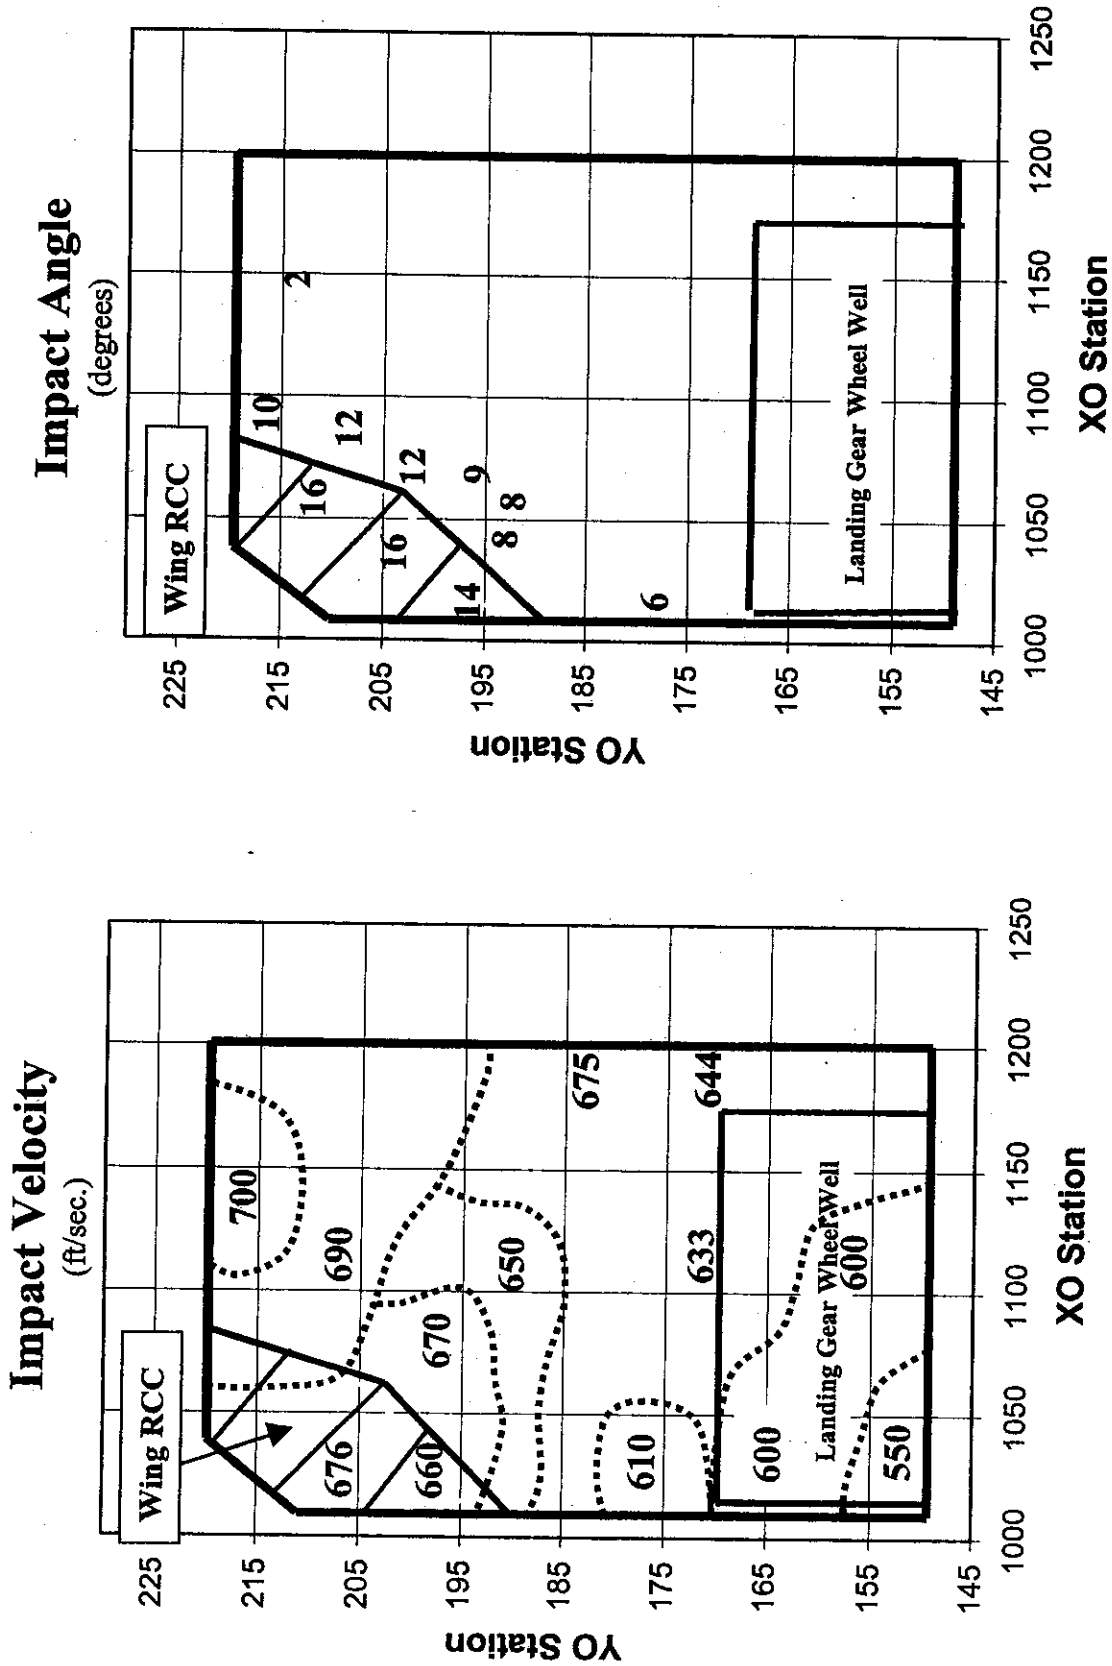
# Velocity and Impact Angle Distribution Inside Impact Area

(Debris Size = 20" x 16" x 6", Density = 2.4 lb/ft<sup>3</sup>)
